Name of Dam: Roanoke No. 72A

Location: Charlotte County, State of Virginia

Inventory Number: VA 03702

## PHASE I INSPECTION REPORT NATIONAL DAM SAFETY PROGRAM

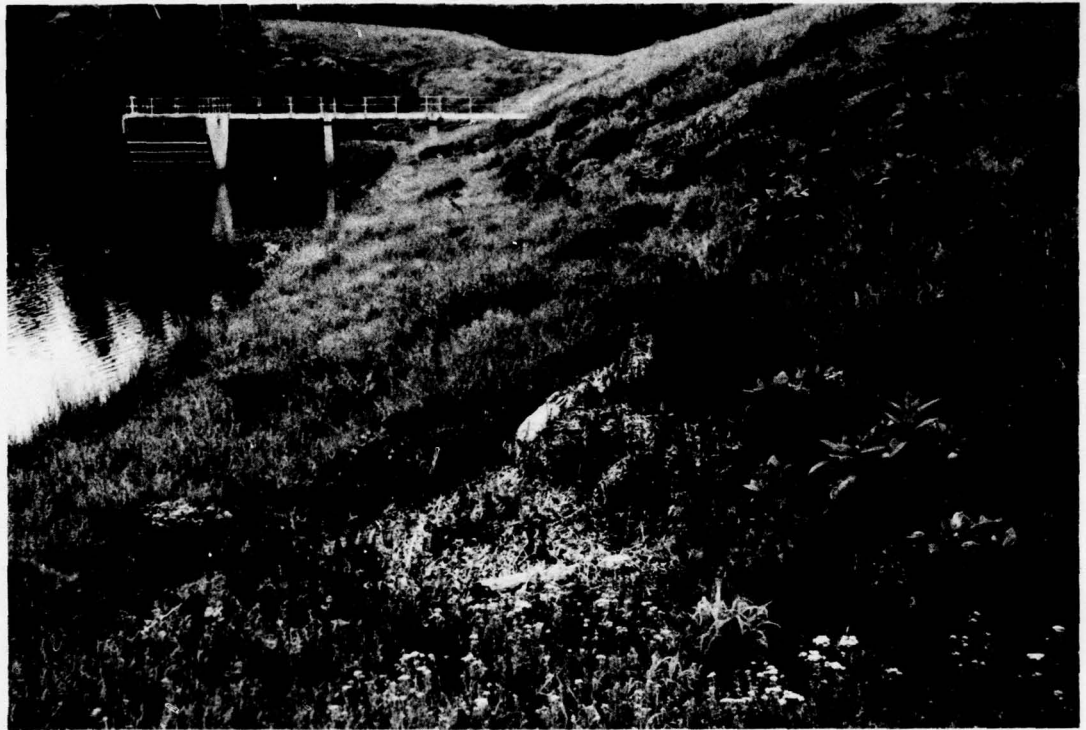
- 3.1.2 Dam: The embankment was found to be in generally good condition with no surface cracks, slumps, or other indications of instability either on the embankment or at the toe. The slopes are well covered with grass and no significant erosion was observed. There are scattered small areas of dried out grass and occasional driftwood on the shoreline of the lake (see Photo 1).

**PHOTO 1. Upstream Embankment, Riser and Reservoir**

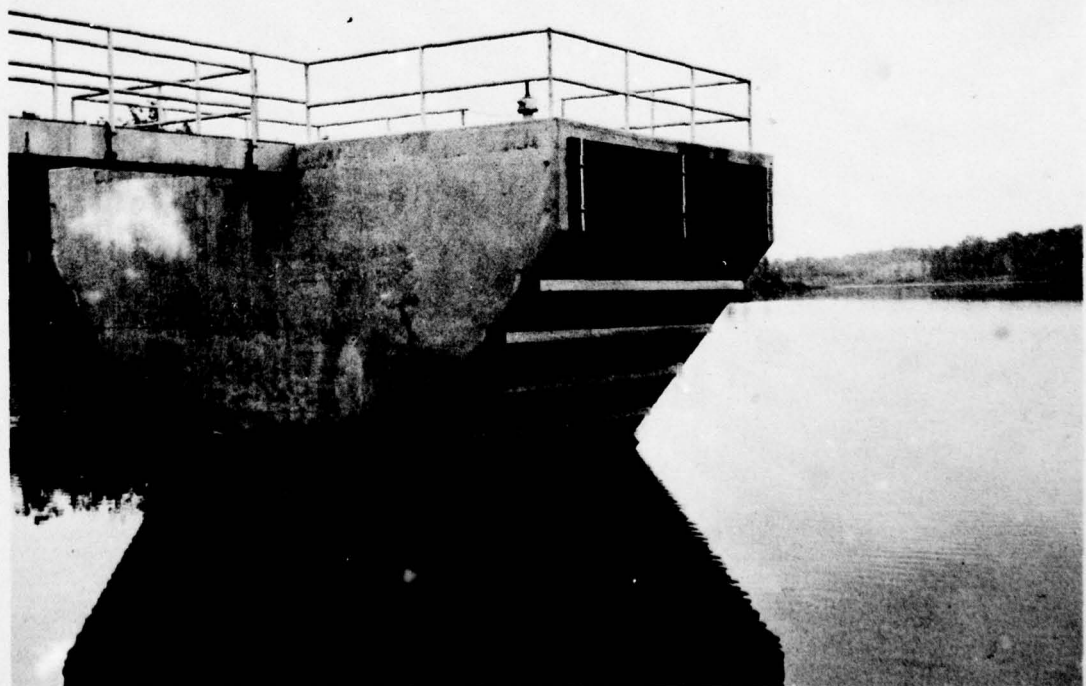
- 3.1.3 Appurtenant Structures: The principal spillway was in good condition (see Photo 6) except for some driftwood lodged in the trash racks of the riser (see Photo 2). There was a flow of approximately 0.25 g.p.m. in the right toe drain. The toe drain to the left of the outlet pipe was not flowing.

3.2 Evaluation: Generally, the dam and appurtenant structures are in good condition. The removal of the driftwood lodged in the trash racks is recommended. The limited copper mining and the spring near the left abutment apparently do not affect the reservoir storage or the stability of the dam.

**PHOTO 2. Close-up View of Riser (Note Debris in Trash Racks)**

It is recommended that the following repair items be accomplished as part of the annual maintenance program: remove debris from the trash racks, observe spring area during yearly inspections, and install a staff gage.

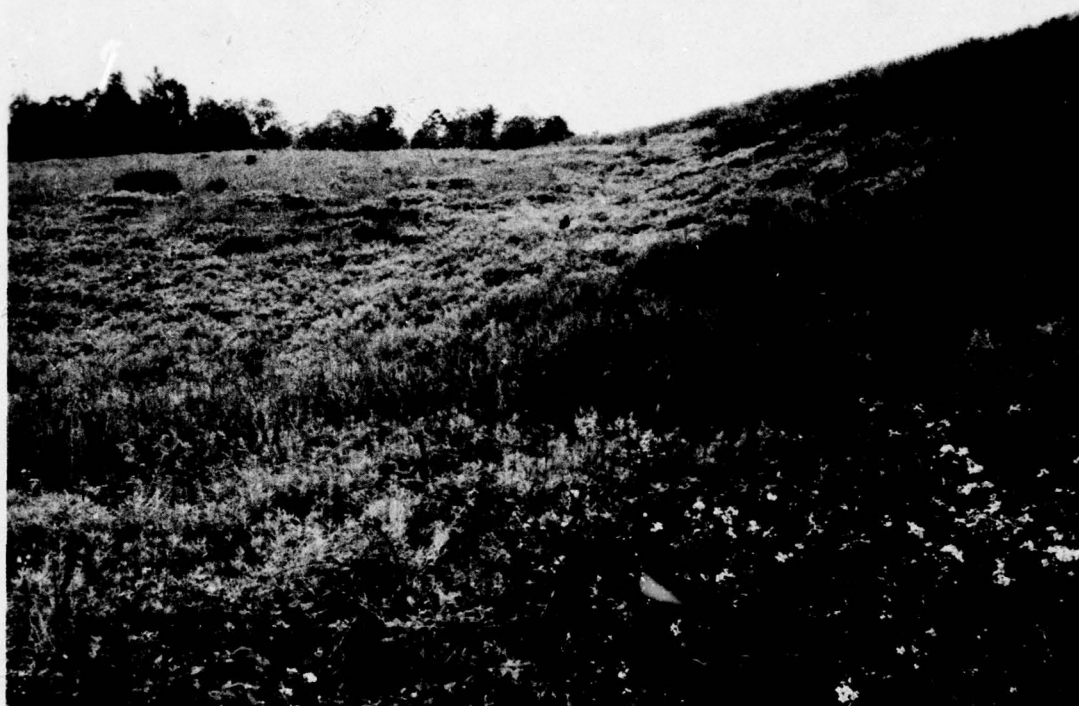
**PHOTO 5. Downstream Embankment Showing Right Abutment Area**

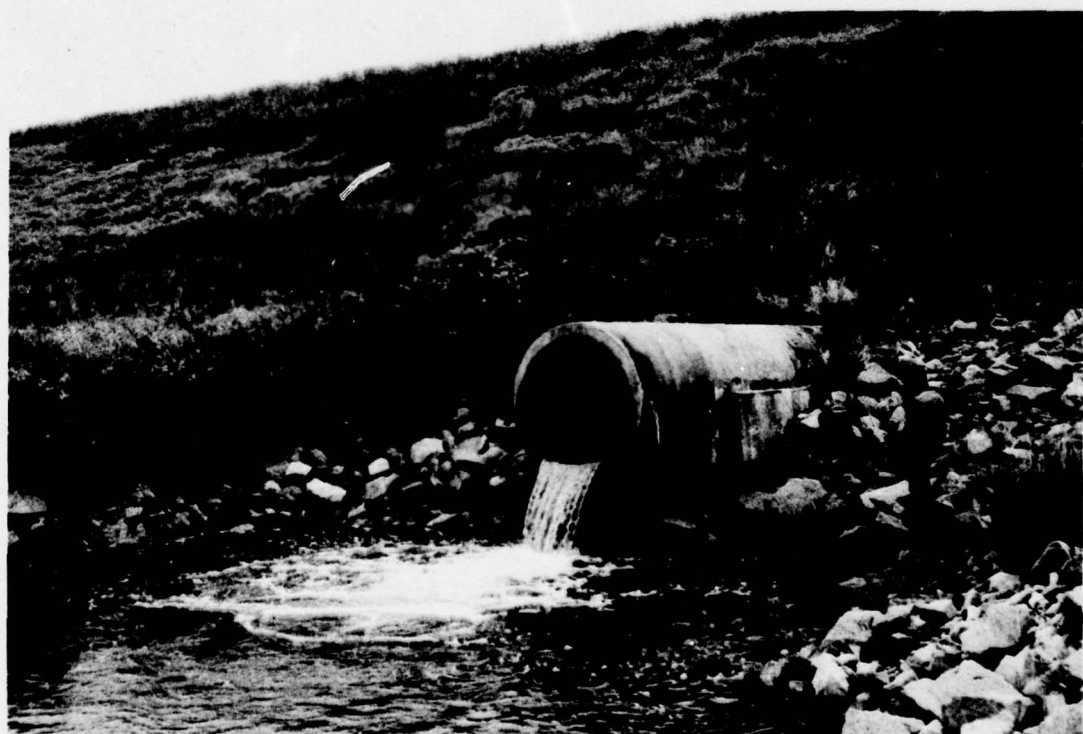
**PHOTO 6. Outlet Pipe, Stilling Basin and Toe Drainpipe**

STAFF GAGE AND RECORDER	None	
DRAINS	One 6 in. C.M.P. toe drain is located on each side of the outlet of the principal spillway. Approximately 0.25 g.p.m. clear water flows from the pipe on the right side. The pipe on the left is dry with red staining, small roots, and silt (1 in. deep).

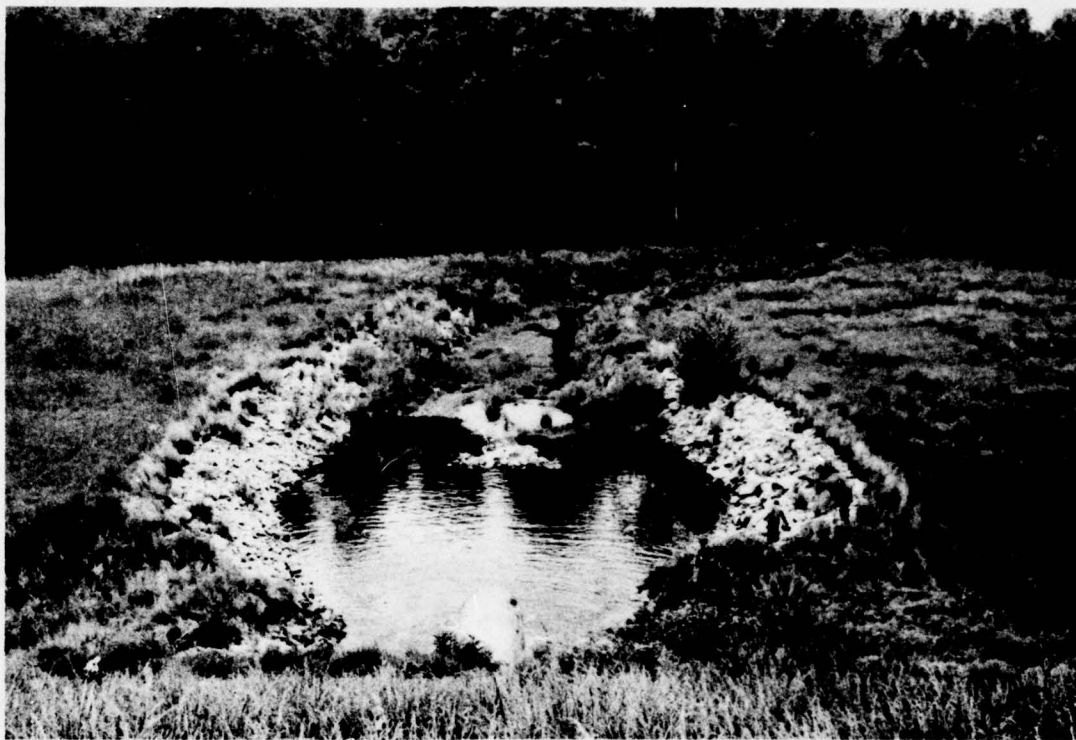
**PHOTO 7. Outlet Pipe, Riprapped Stilling Basin and Downstream Channel**

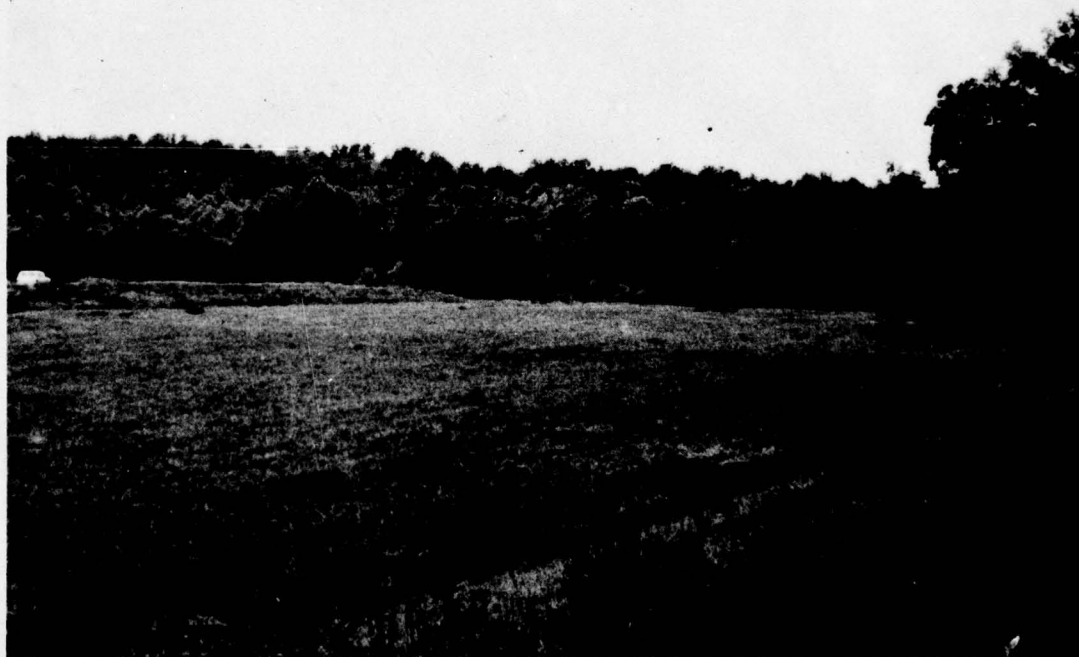
**PHOTO 8. Downstream View of Emergency Spillway and Right Abutment**
